Safety Flashes are produced by the Marlborough Safety Forum. They are intended to summarise key safety matters and incidents and allow wider distribution of lessons learnt. The effectiveness of the safety flash system depends on receiving reports from members in order to pass on information and avoid repeat incidents.

1 Loss of eye sight

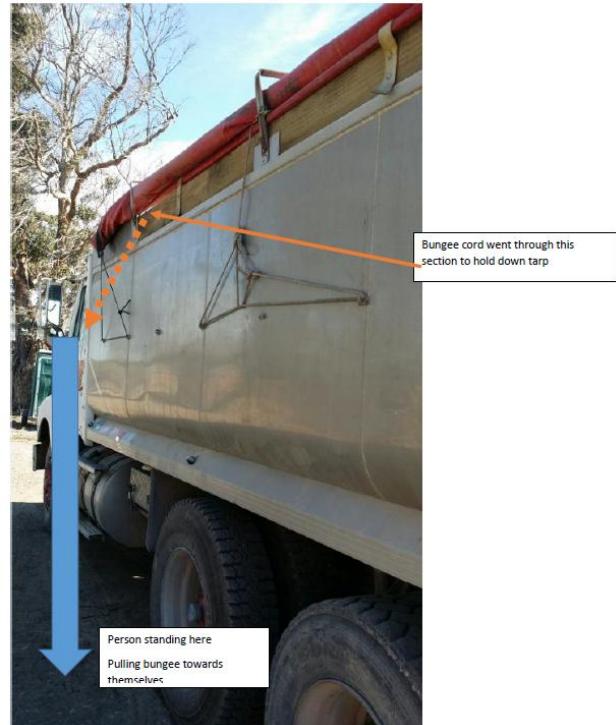
A worker was struck in the eye with a bungee cord (occy strap) causing permanent damage. A bungee cord was put on as an addition to stop the rolled up tarp on a truck from flapping during transit. The worker was removing a bungee cord which was stuck, when it came loose it released with stored energy. The cord hit the worker in the eye.

The injured workers was seen by accident and emergency but has lost partial sight in his right eye. The worker has been able to return to full duties. This incident has been reported to WorkSafe and a duty holder review completed.

- Cover was modified in attempt to do the right thing.

- Worker was not aware of the hidden energy in the bungee
- Cover not fit for purpose as it had a quick fix on it
- Contributing factors: Are additional events or non-actions that allowed the incident to occur.
- Proper risk assessment not conducted on a modification.

Risk assessments need to be conducted for all equipment brought on site or modified to ensure fit for purpose and any hazards are identified and controlled prior to operational use.

- The tarp has been removed and a re-designed tarp fitted so that a bungee cord is no longer needed.
- All bungee cords were removed and the issue fixed properly.
- A review of potential gaps in the safety management system identified that some of the administration processes need to be reviewed and re-implemented.
- Situational awareness campaign was run across the business.
